MANDATORY SERVICE LETTER

SL-200C/400C-0002

TO: ALL OWNERS / OPERATORS OF AFFECTED PROPELLERS
SUBJECT: MANDATORY BLADE FERRULE ROOT MODIFICATION
DATE: FEBRUARY 4, 2003

MODELS AFFECTED: All Whirl Wind 200C Series and 400C Series aerobatic propellers manufactured prior to the date of this letter.

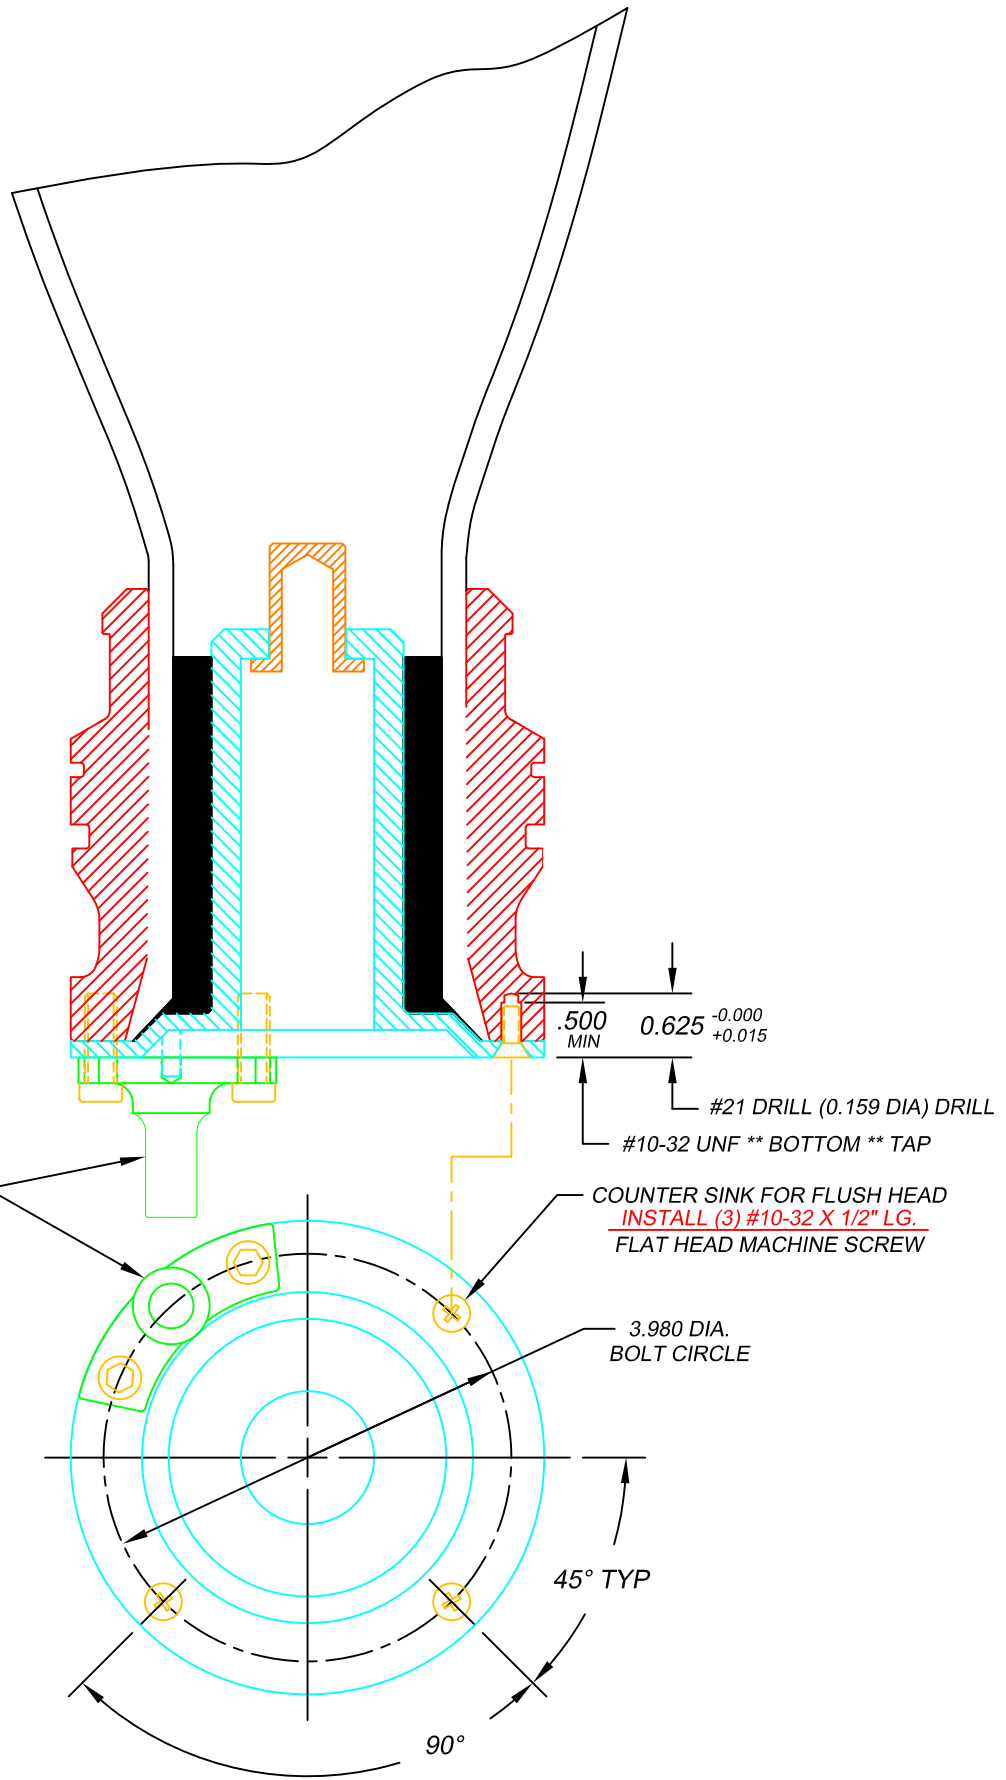
200C / 400C SERIES PROPELLER SL-200C-400C-0002 FASTENER INSTRUCTIONS

REASON: Blade root inner ferrule may slip resulting in loss of pitch control in affected propeller models.

P/N: WWA-200-002
 200C 0.50" DIA. PIN BASE
 ** PER SL-200C-051805
 P/N: WWA-400-003
 400C 0.44" DIA. PIN BASE

1. A blade ferrule root modification must be performed for all affected propeller models. This modification will require the affected propeller models to be disassembled for the removal of the blades. The blade modification requires three #10 fasteners to be installed at the ferrule root of each blade. After the blade modification is complete, the propeller can then be reassembled and returned to regular service.
2. This modification can be performed by the Whirl Wind Propellers factory. Alternatively, a modification kit will be provided to a qualified propeller service center to perform this modification per Whirl Wind drawing upon approval by Whirl Wind.

.500
 MIN
 0.625 ^{-0.000}/_{+0.015}
 #21 DRILL (0.159 DIA) DRILL
 #10-32 UNF ** BOTTOM ** TAP
 COUNTER SINK FOR FLUSH HEAD
INSTALL (3) #10-32 X 1/2" LG.
 FLAT HEAD MACHINE SCREW
