Service Letter No: SL-200C/400C-070214

DATE: July 8, 2014

SUBJECT: Inner ferrule to outer ferrule screw modification per 2003 Service Letter SL-200C/400C-0002 (attached for reference).

MODELS AFFECTED: Early 200C and 400C propellers subject to 2003 Service Letter SL-200C/400C-0002; 200C propellers serial numbers 200C-238 and lower and 400C propellers serial numbers 400C-236 and lower.

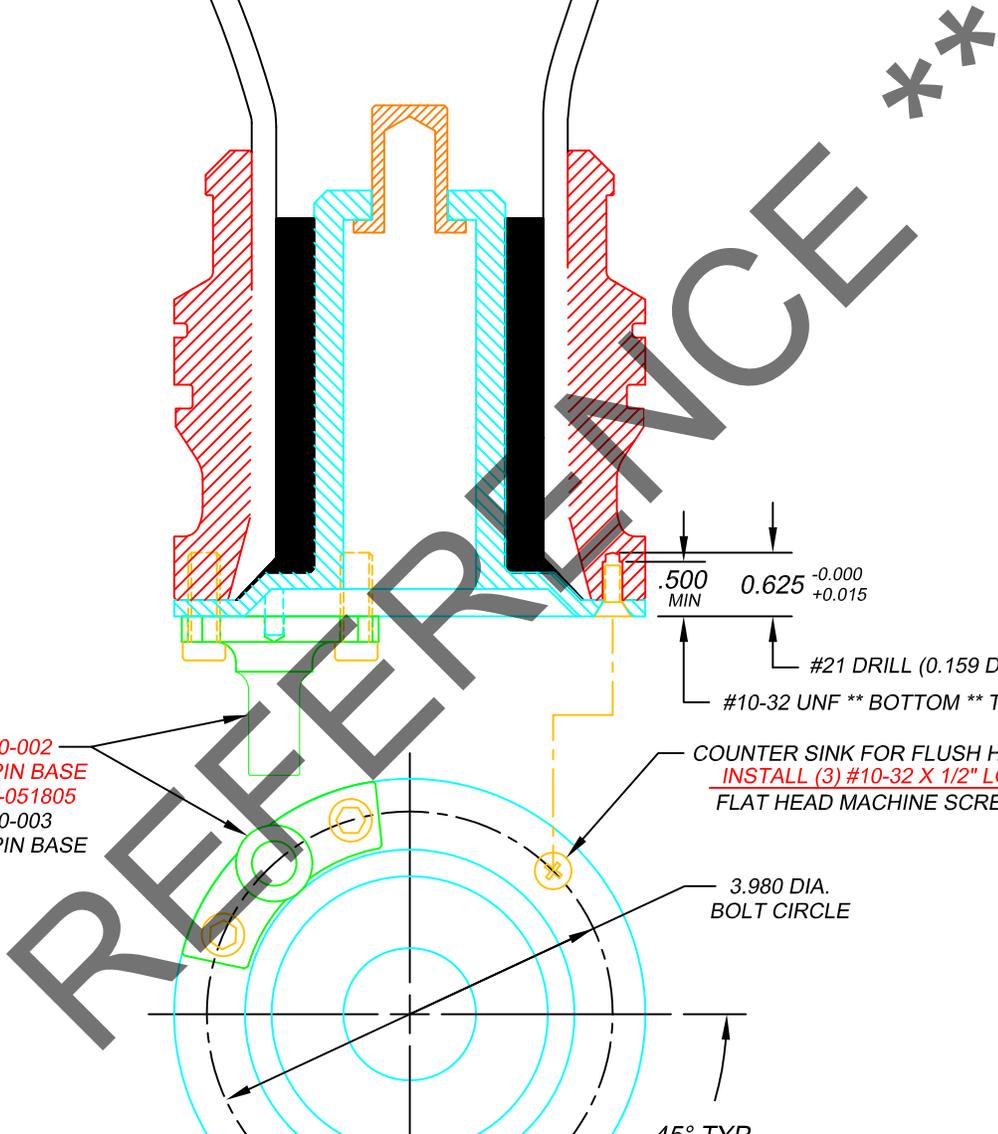
200C / 400C SERIES PROPELLER SL-200C-400C-0002 FASTENER INSTRUCTIONS

REASON: Per Service Letter 200C/400C-0002 the additional specified #10-32 tap holes may be drilled too deep, which may compromise the blade outer ferrule integrity and lead to fracturing and possible loss of blade retention.

COUNTER SINK FOR FLUSH HEAD
 INSTALL (3) #10-32 X 1/2" LG.
 FLAT HEAD MACHINE SCREW

.500
 MIN 0.625 ^{-0.000}/_{+0.015}

#21 DRILL (0.159 DIA) DRILL
 #10-32 UNF ** BOTTOM ** TAP

Through testing and / or removal of the #10-32 inner ferrule screws (those dictated by service letter SL-200C/400C-0002) the drill depth of the screw holes must be less than 0.625" from the surface of the inner ferrule to the drill point. Blades with holes exceeding this maximum allowable depth must be taken out of service.

Blade ferrules that have screw holes within the maximum depth of 0.625" and are NDT tested and verified to be structurally sound (no evidence of cracks) may be returned to service, continuing to follow the aerobatic propeller 250 hour or annual tear down inspection service interval, whichever comes first.
